Allied Paper, Inc./Portage Creek/Kalamazoo River Superfund Site

Plainwell No. 2 Dam Area Reconnaissance Photographs

November 20, 2008

A compilation of photographs taken by Mike Erickson of ARCADIS and Sam Borries of USEPA

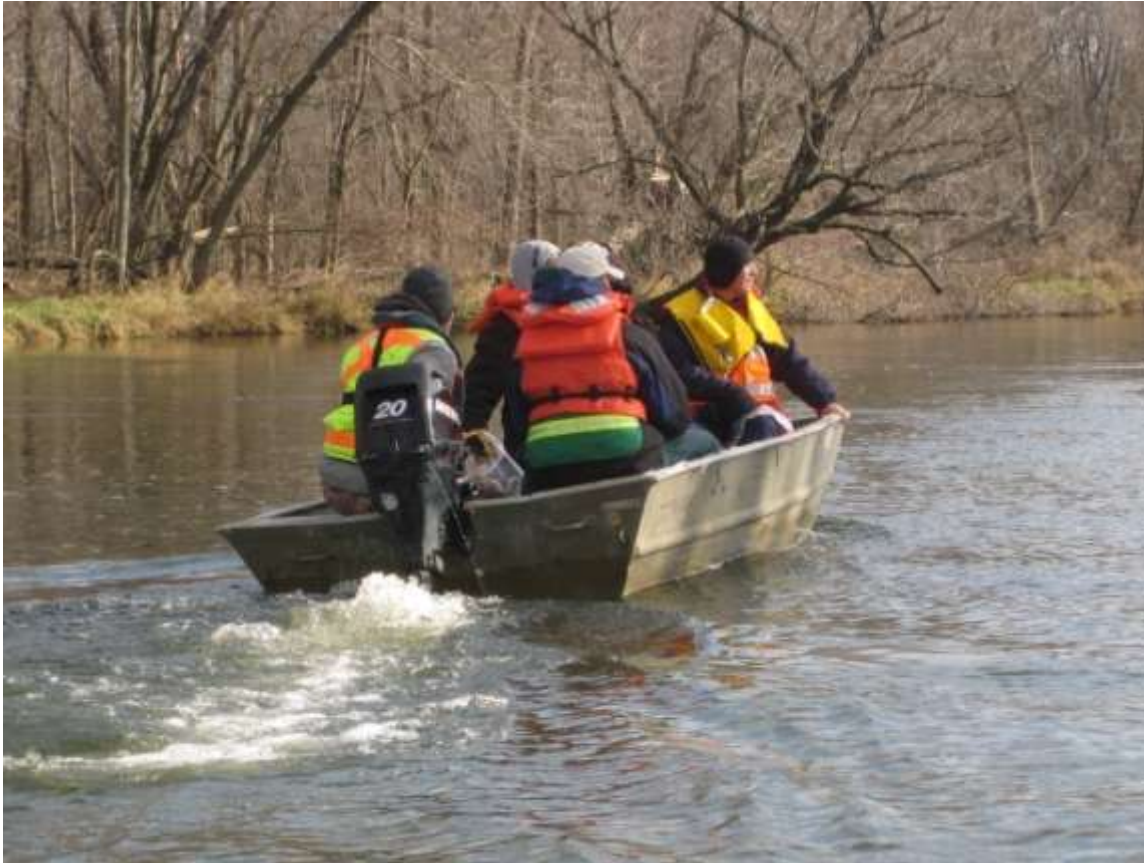
Evidence for hardship pay request.

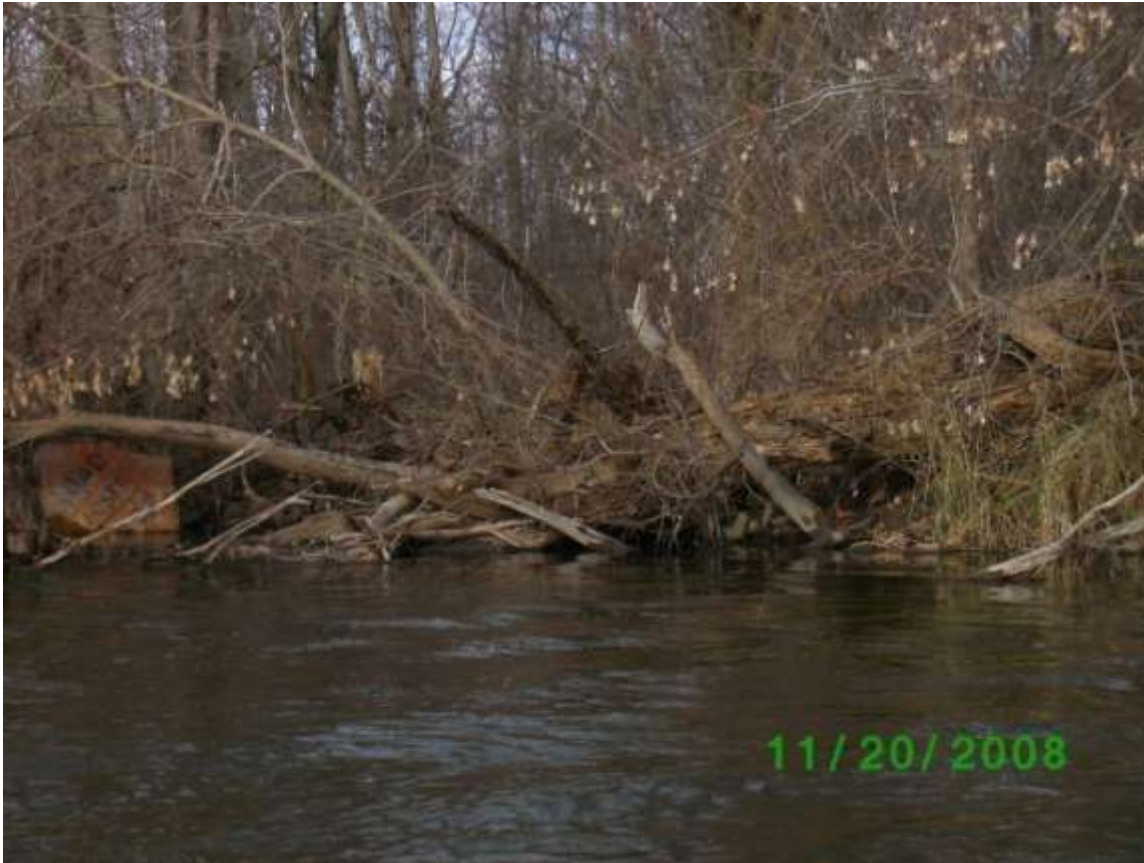
Interesting spot for a “Road Closed Sign”.

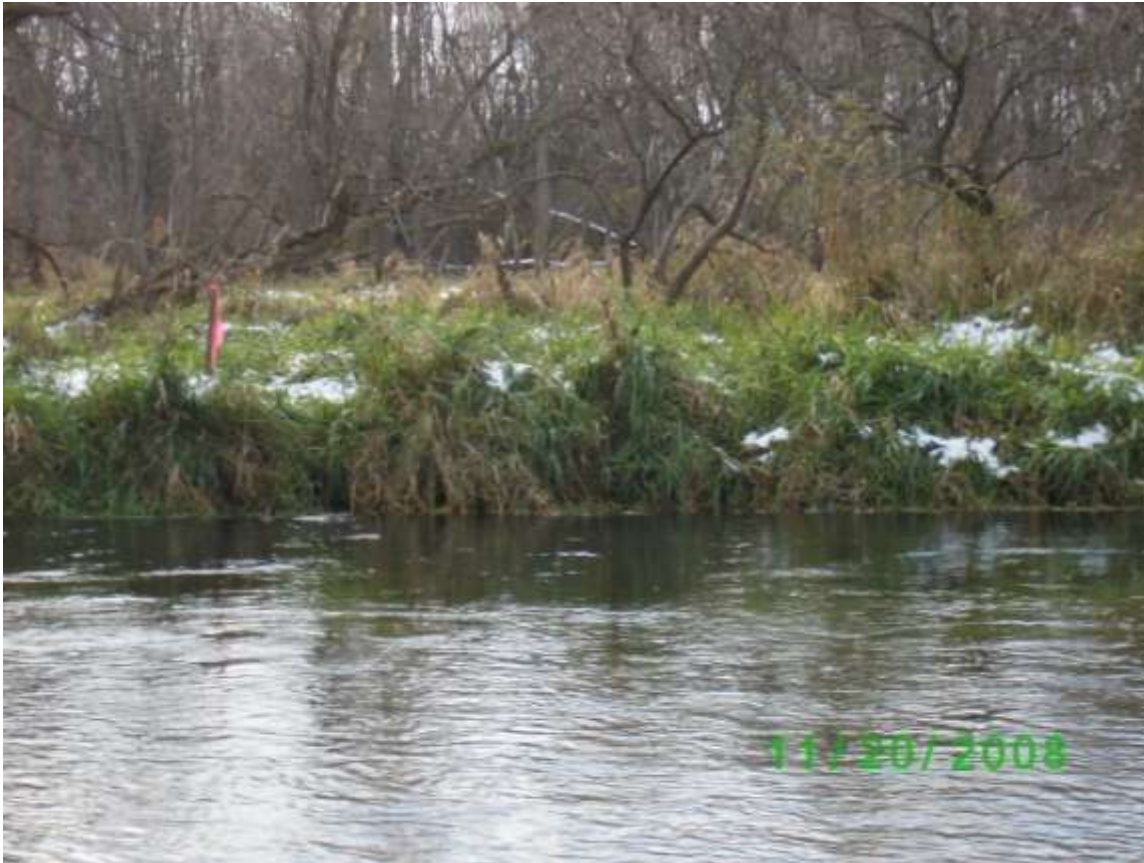
Grassy bank.

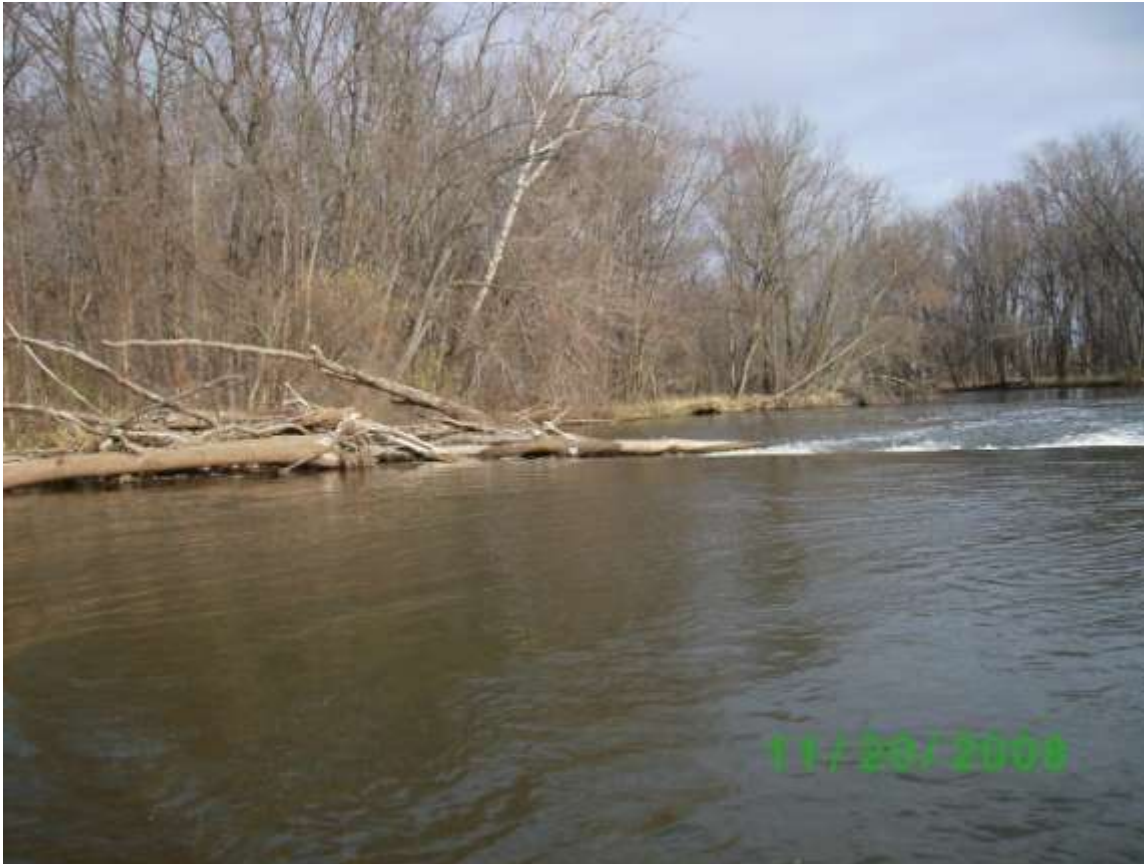
Left bank at right diversion structure.

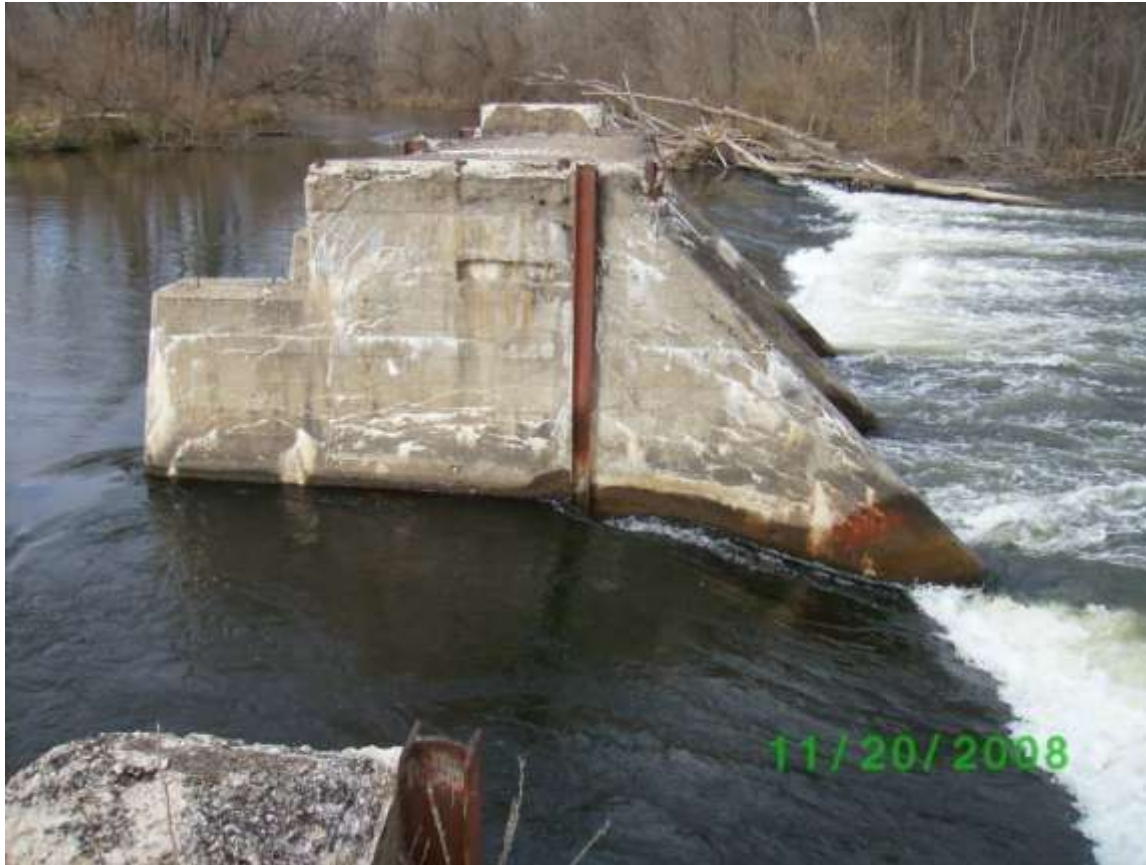
Right diversion structure.

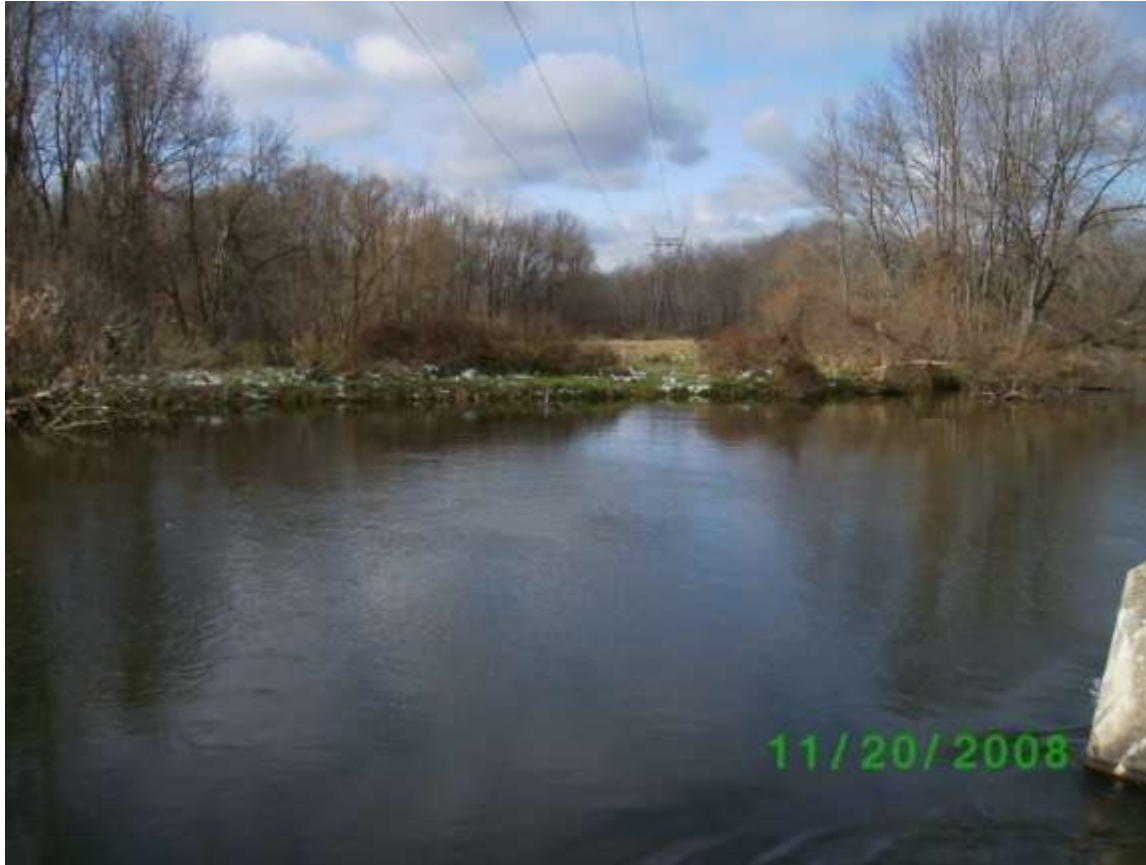
View along power line from right diversion structure.

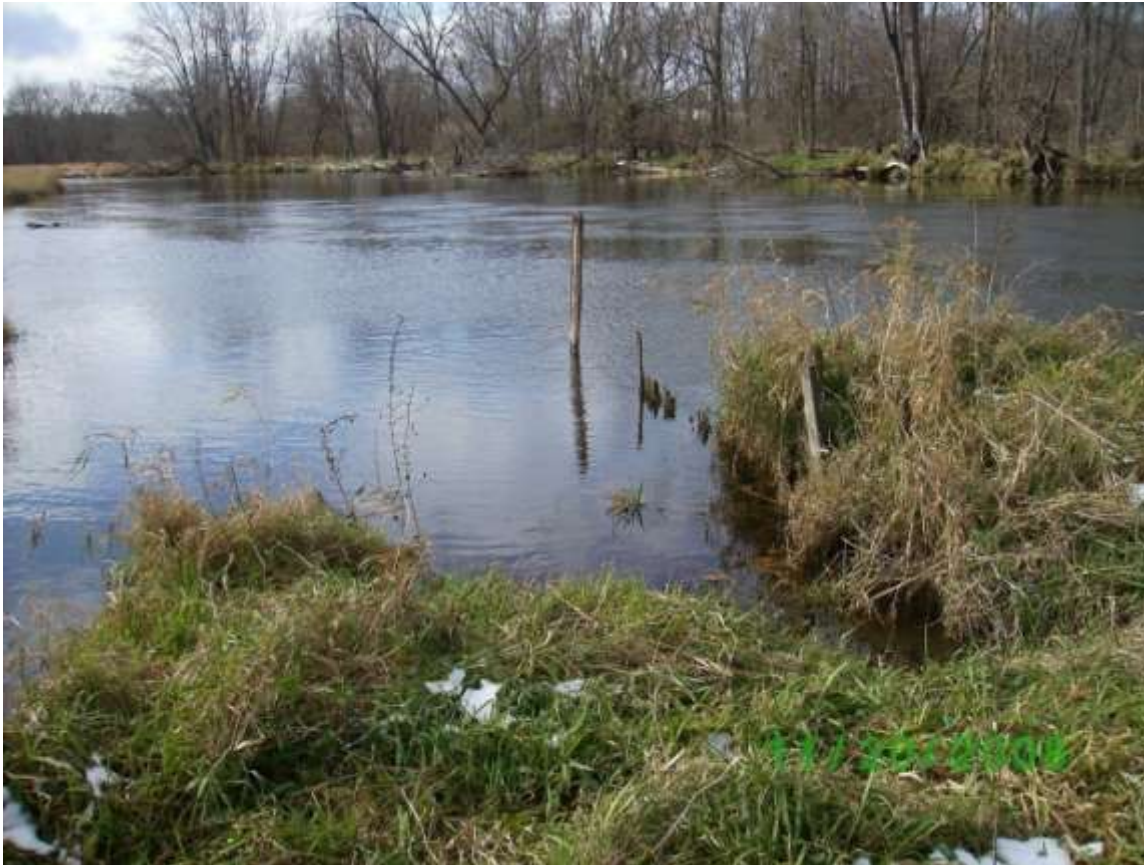
Apparent relict canoe take out location for portage path.

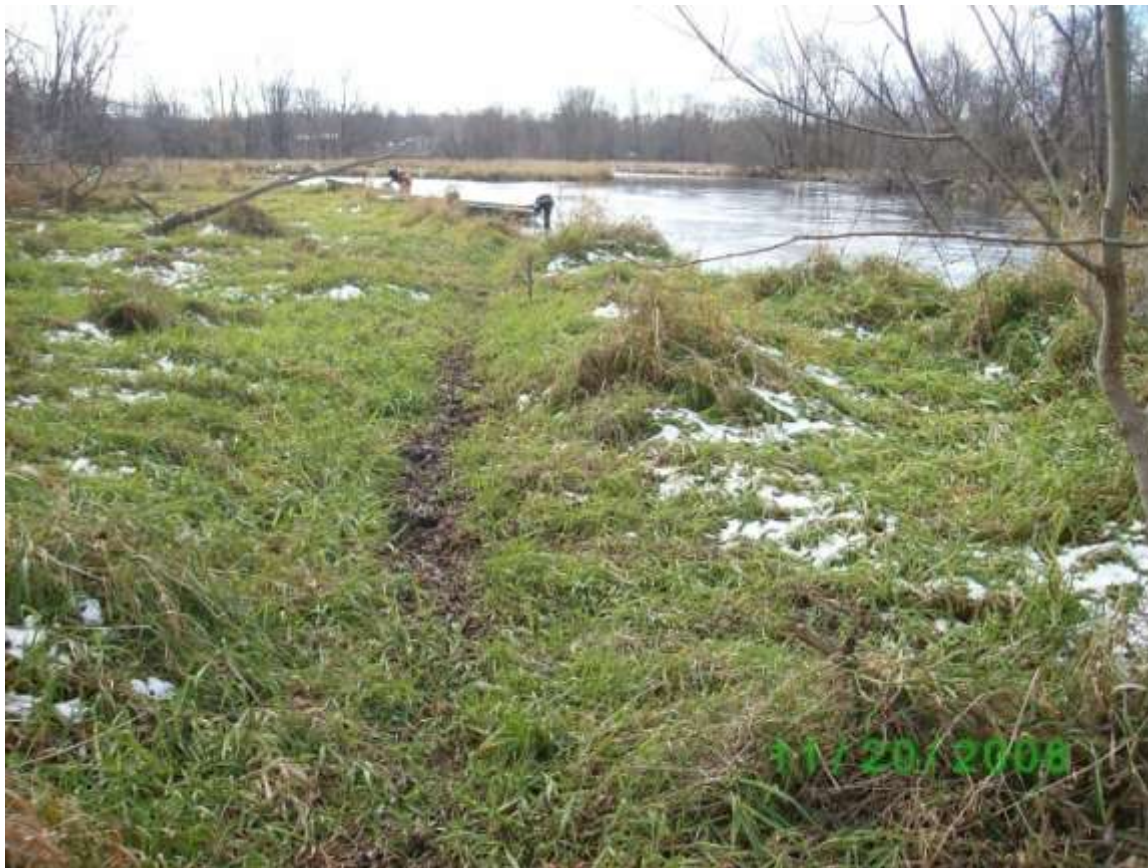
Portage path around right diversion structure.

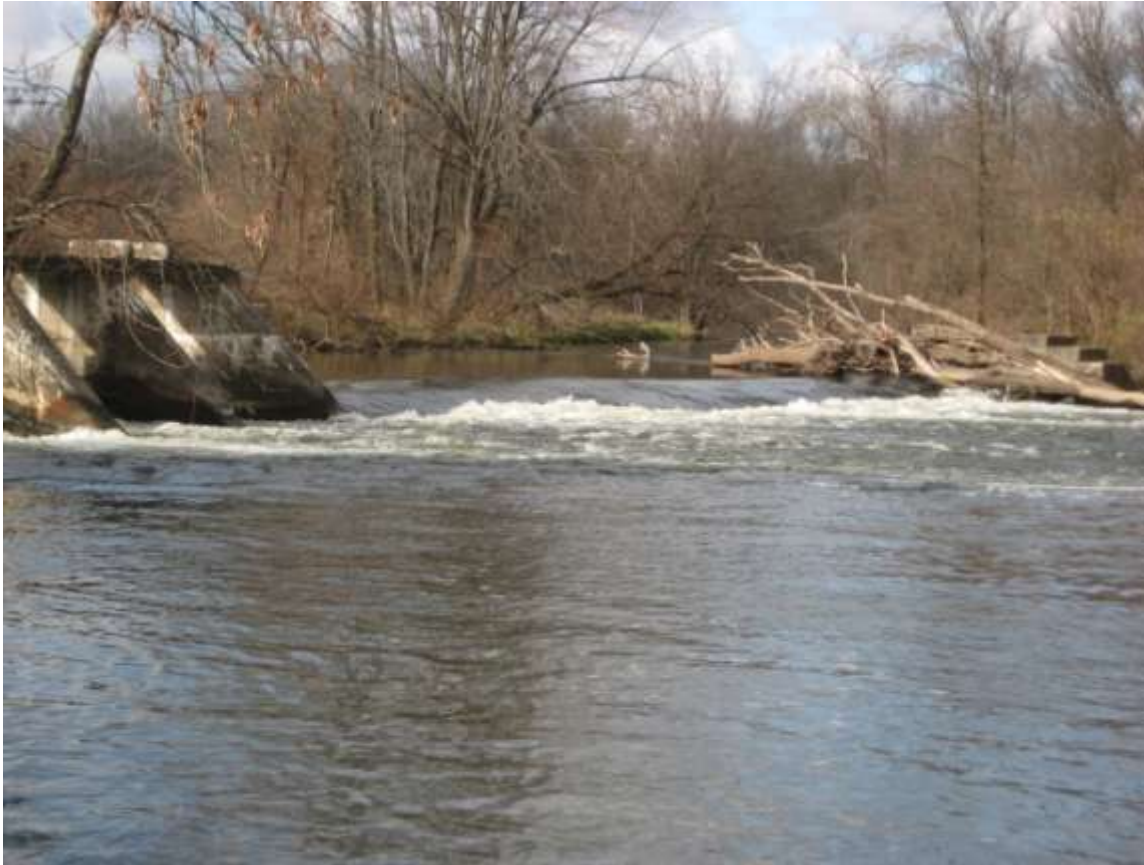
View of downstream side of right diversion structure.

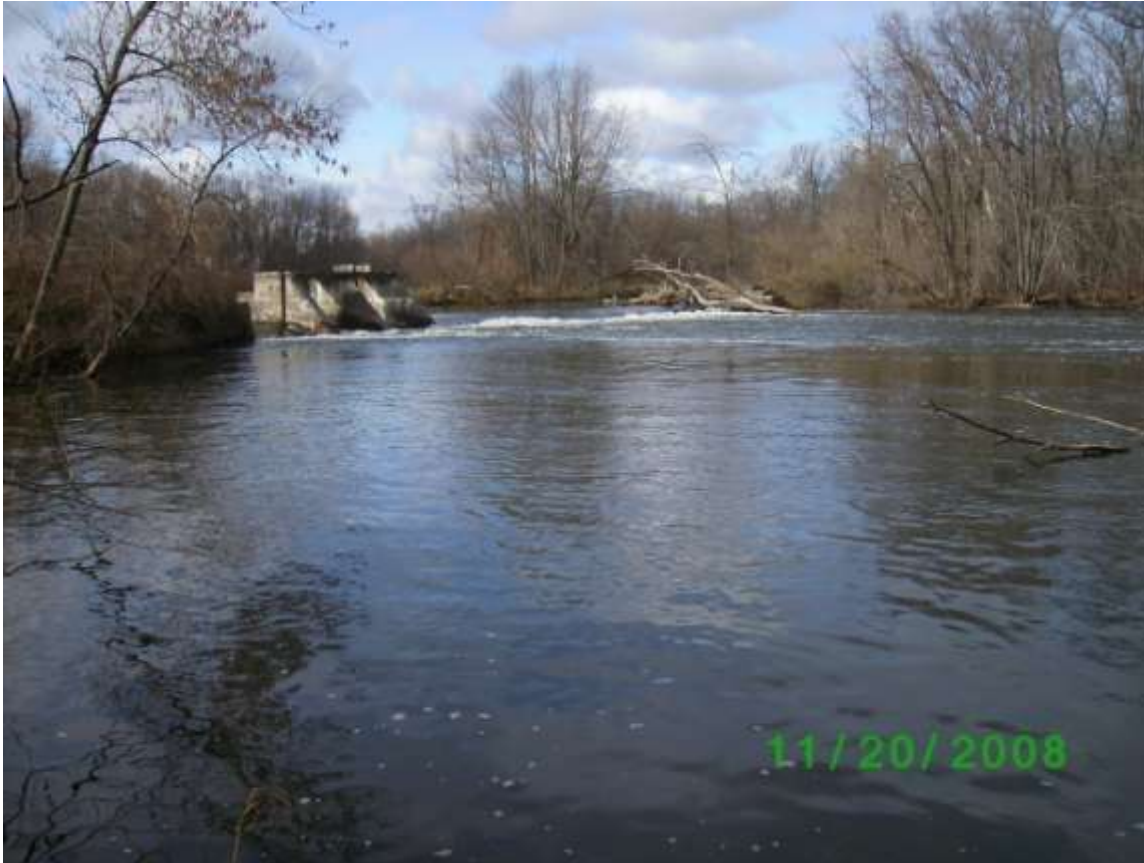
View of downstream side of right diversion structure.

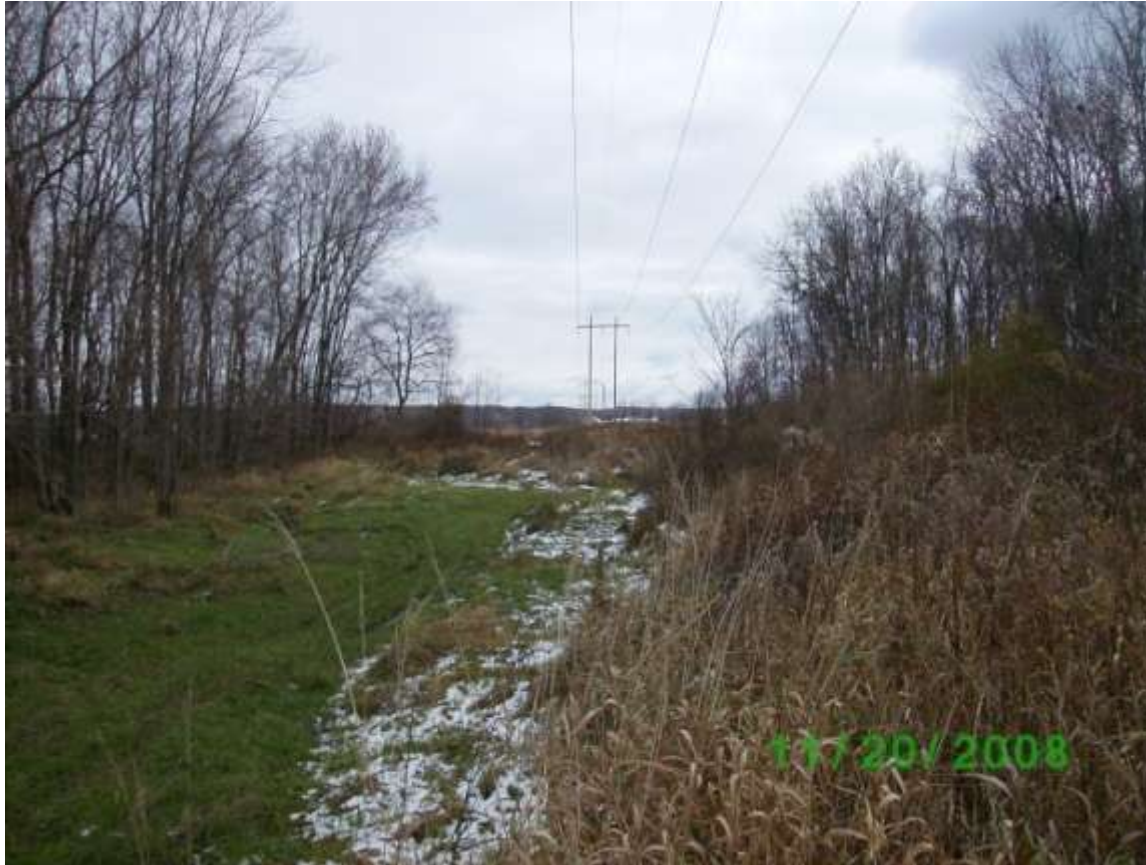
View to north east along power line. Notice berm to right and access road to left.

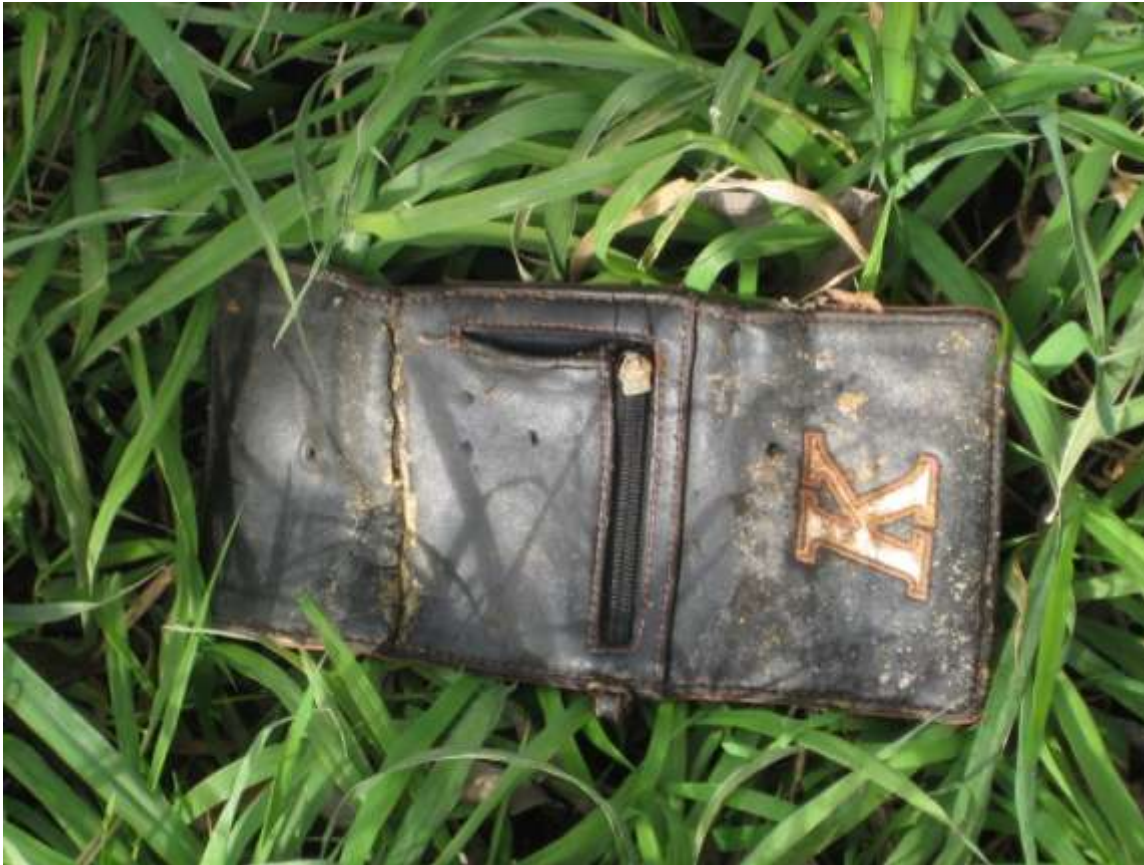
Photo caption contest....(wallet downstream of right diversion structure)

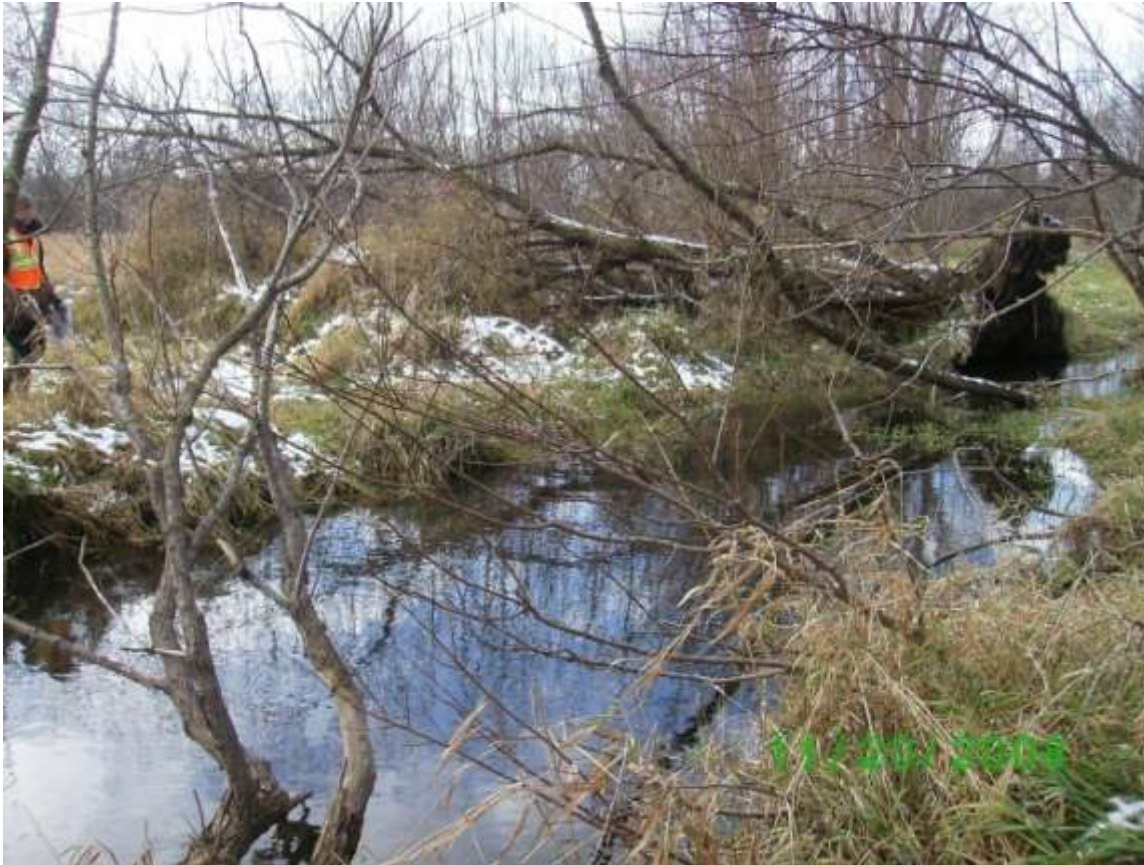
Mouth of oxbow.

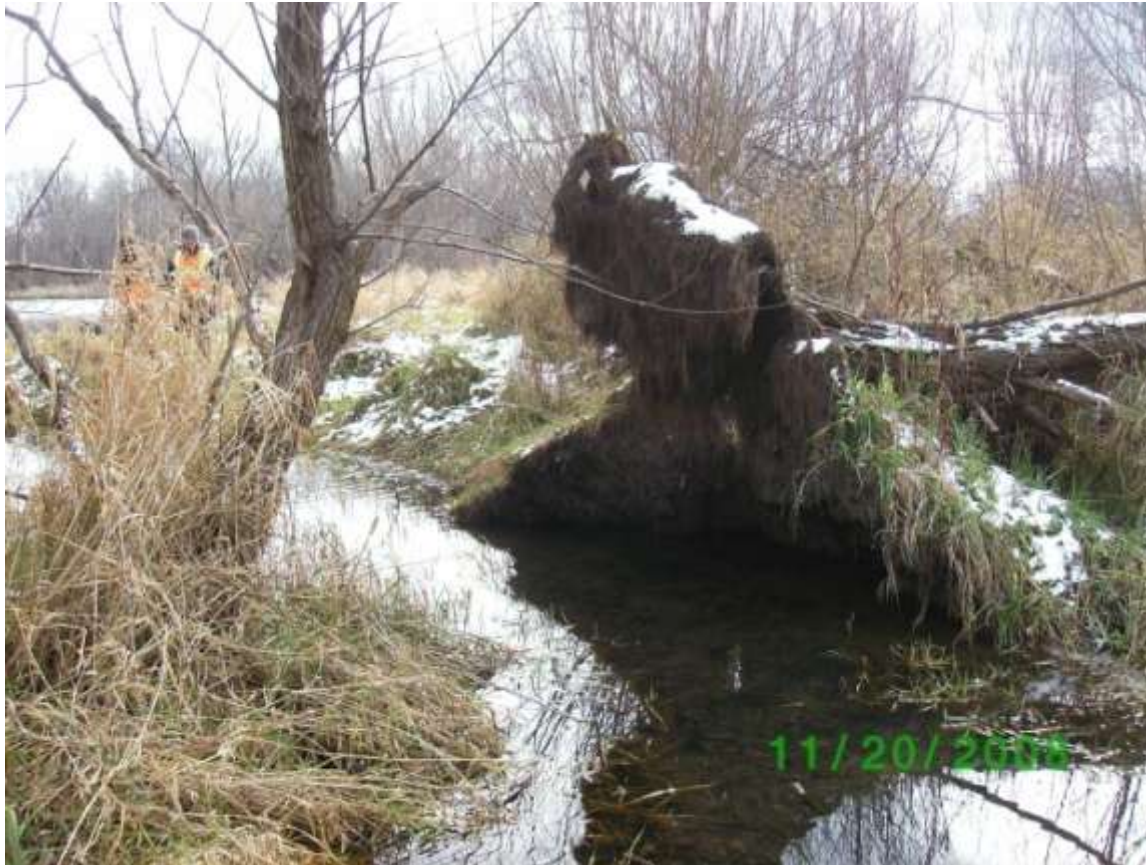
Mouth of oxbow and up-turned root mass.

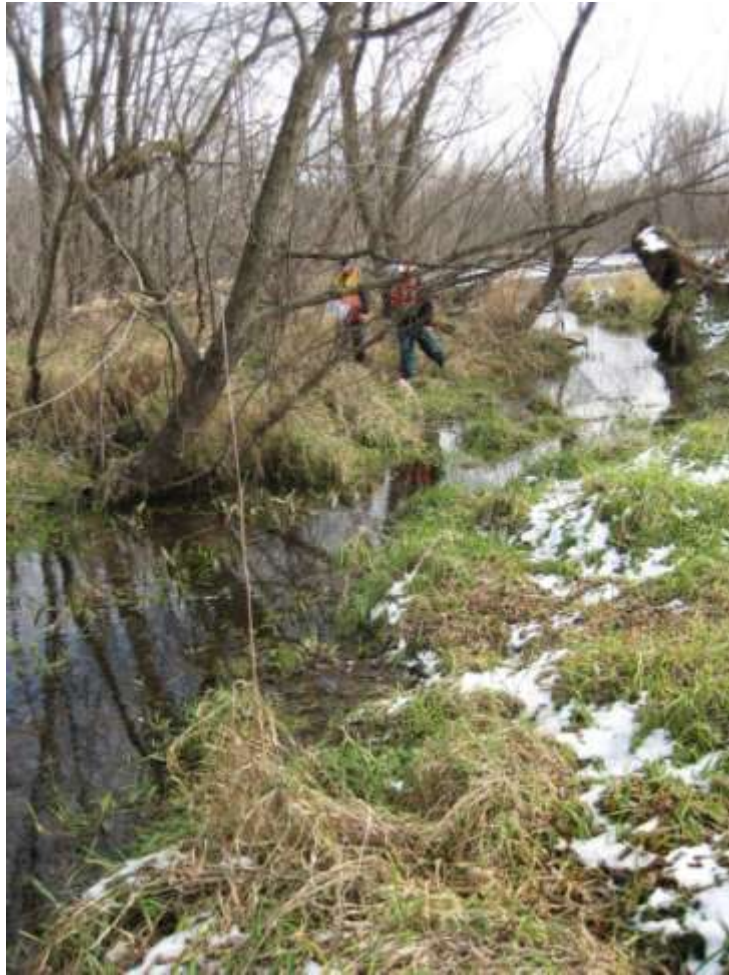
Tree root mass at mouth of oxbow.

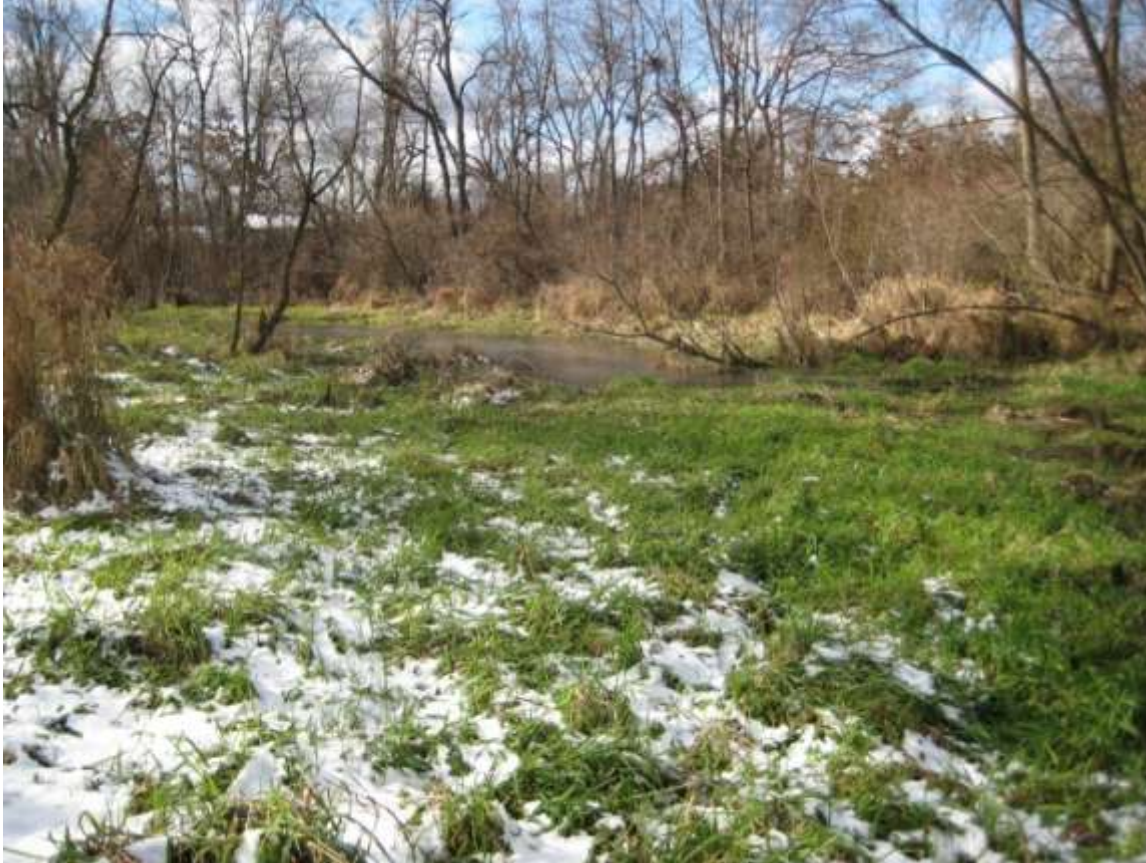
View along oxbow toward mouth.

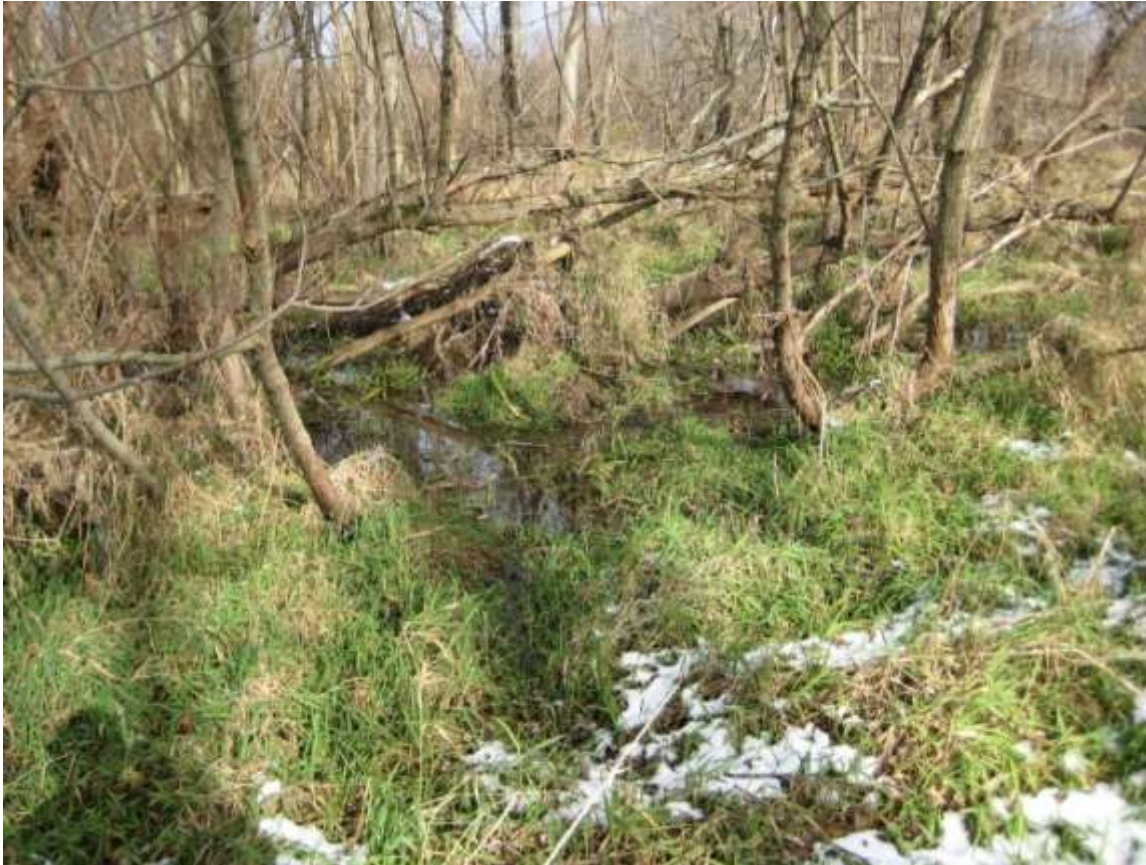
Brushy area short distance from river along oxbow.

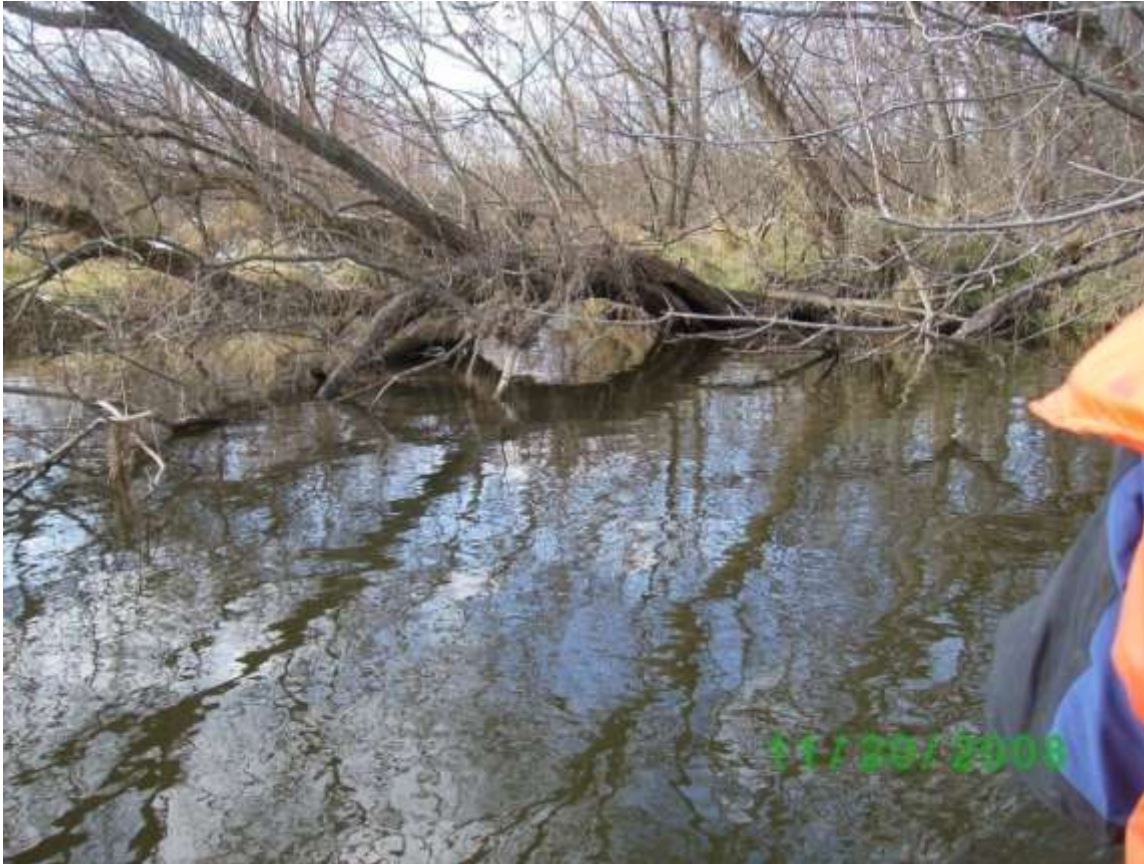
View of mouth of oxbow from river.

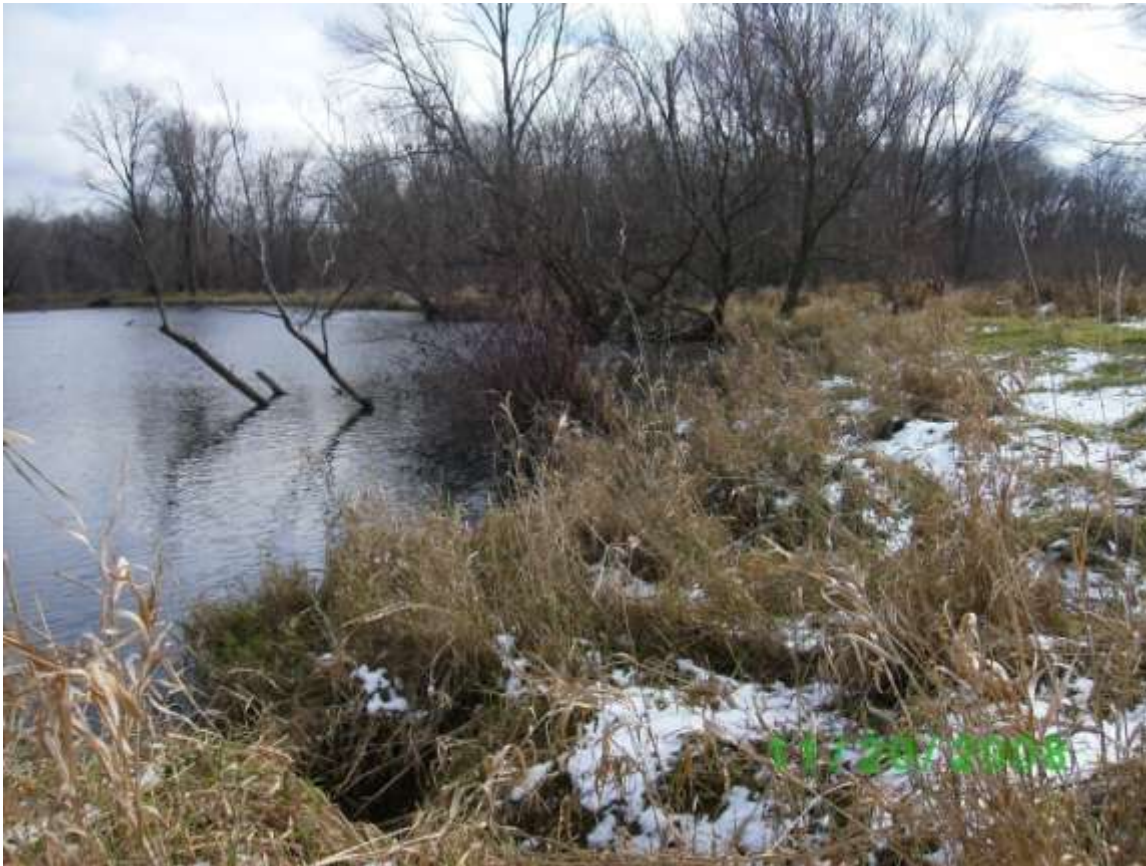
View to south along bank from mouth of oxbow.

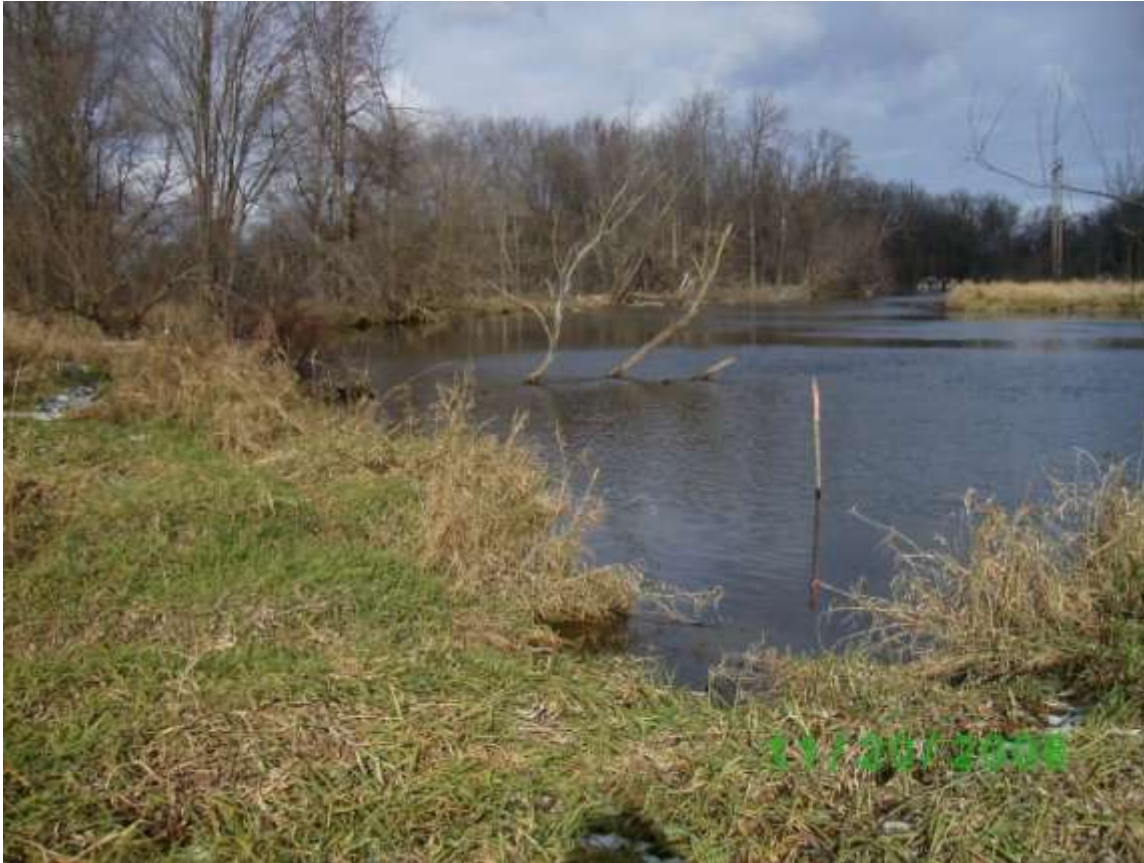
View to north along bank at mouth of oxbow.

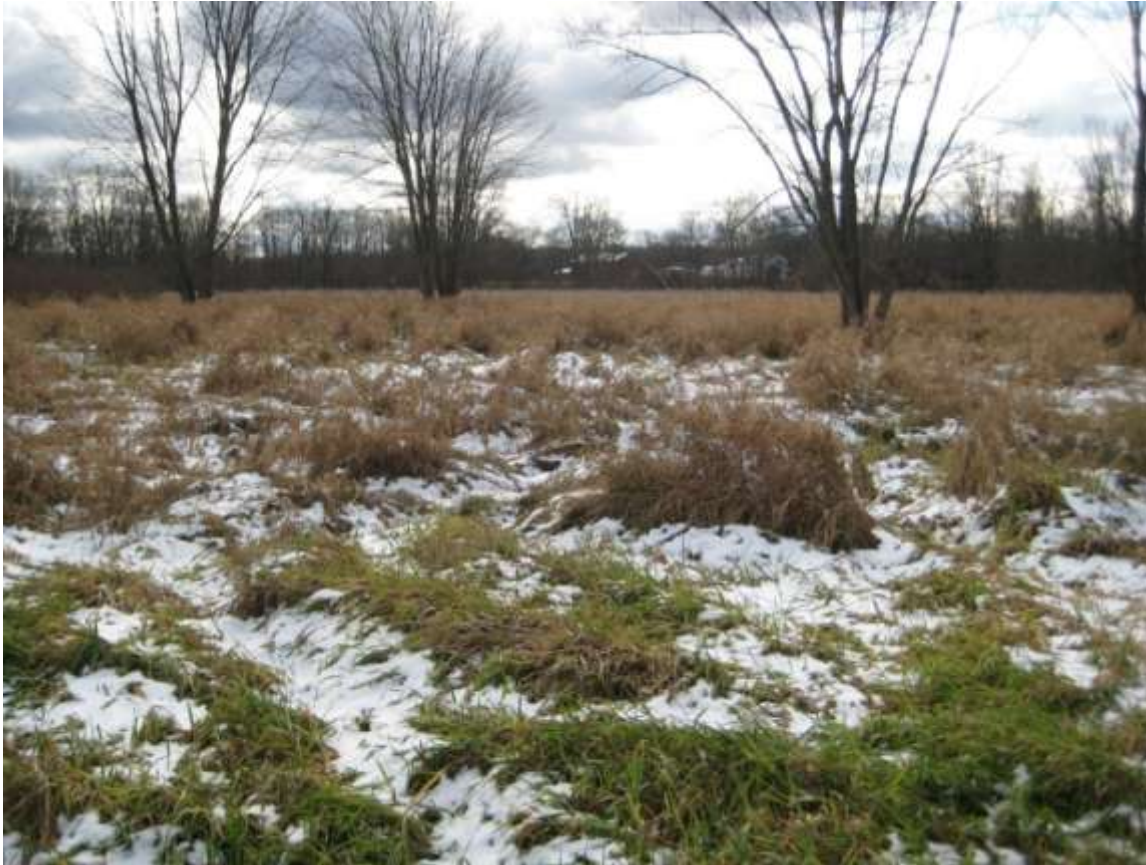
Marsh area enclosed by oxbow.

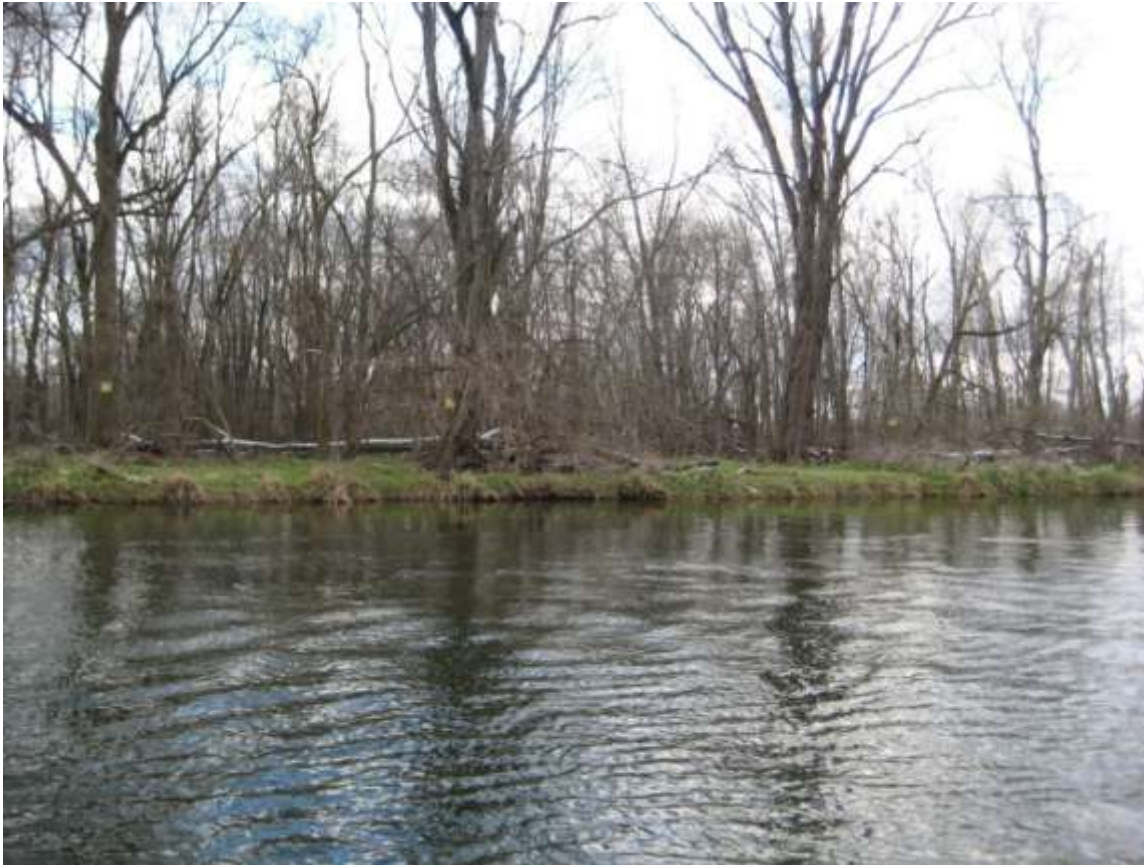
Near upstream end of oxbow.

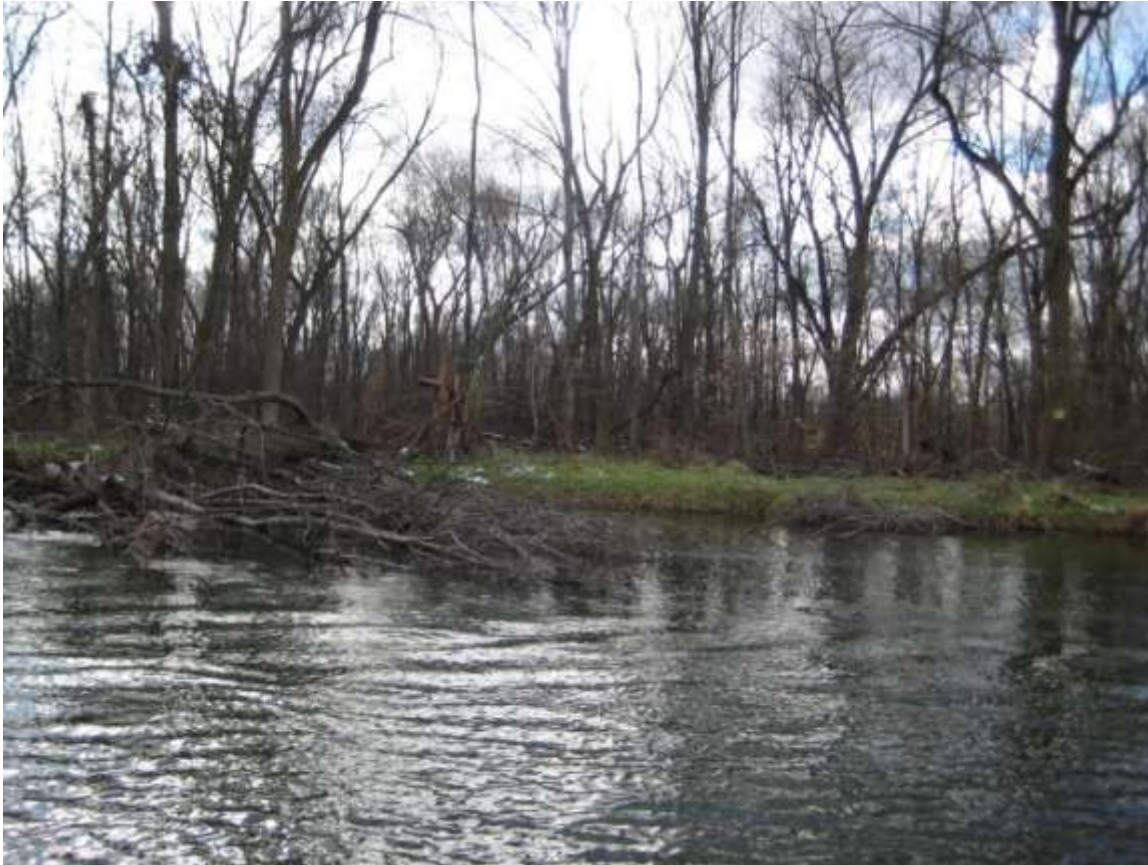
Near upstream end of oxbow.
